Abstract

This research project investigated the effect of cyclic loading on bone as a result of loading on hard and soft surfaces. The results show that there is a substantial difference in the amount of damage accumulated in the bone as a result of the two tests. However there is a concern that the amplitude of the loading during the soft test didn't fully match the amplitude of the loading in the hard test. Thus, more tests need to be carried out.

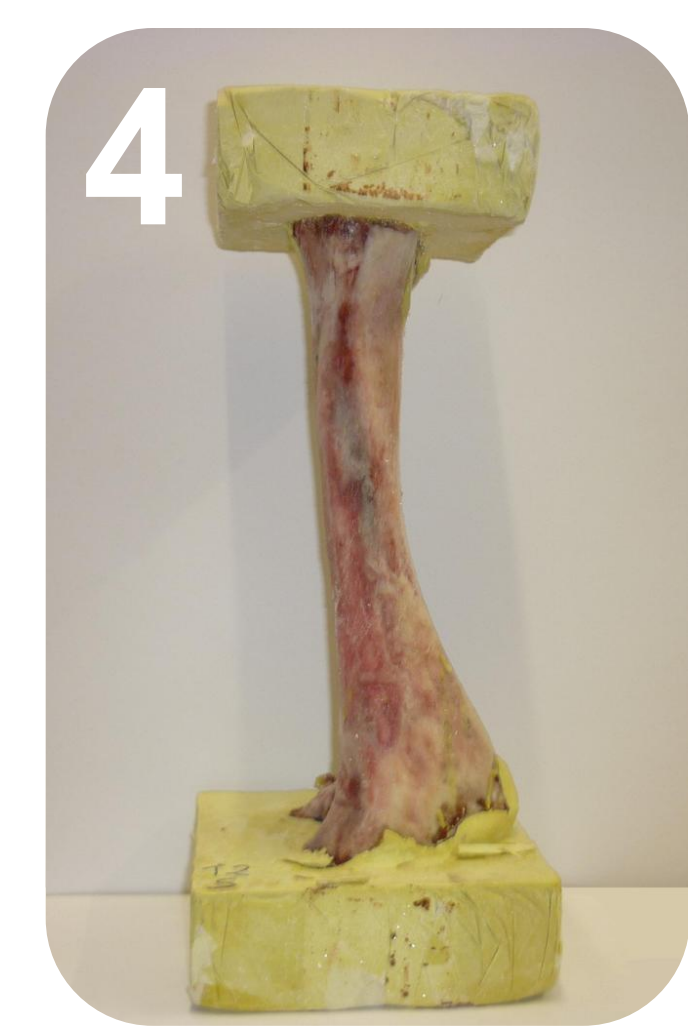
5.) The moulded bones were then clamped into position on the Instron 8874 servo hydraulic materials testing machine using a custom built rig. Each rig had the capacity to mimic either a hard surface or a soft surface depending on whether springs were installed or not. Each bone was then cyclically loaded for 50,000 cycles and the change in deflection between start and finish measured.

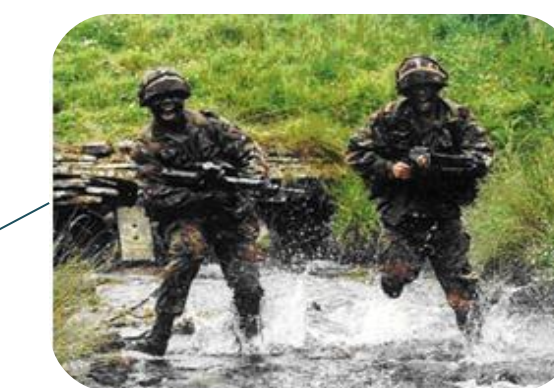
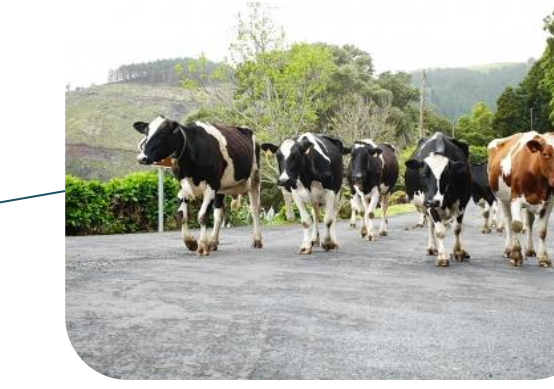
1.) Bovine tibiae were sourced from a local abattoir, carefully disjointed from their corresponding femurs and cleaned of all soft tissue.

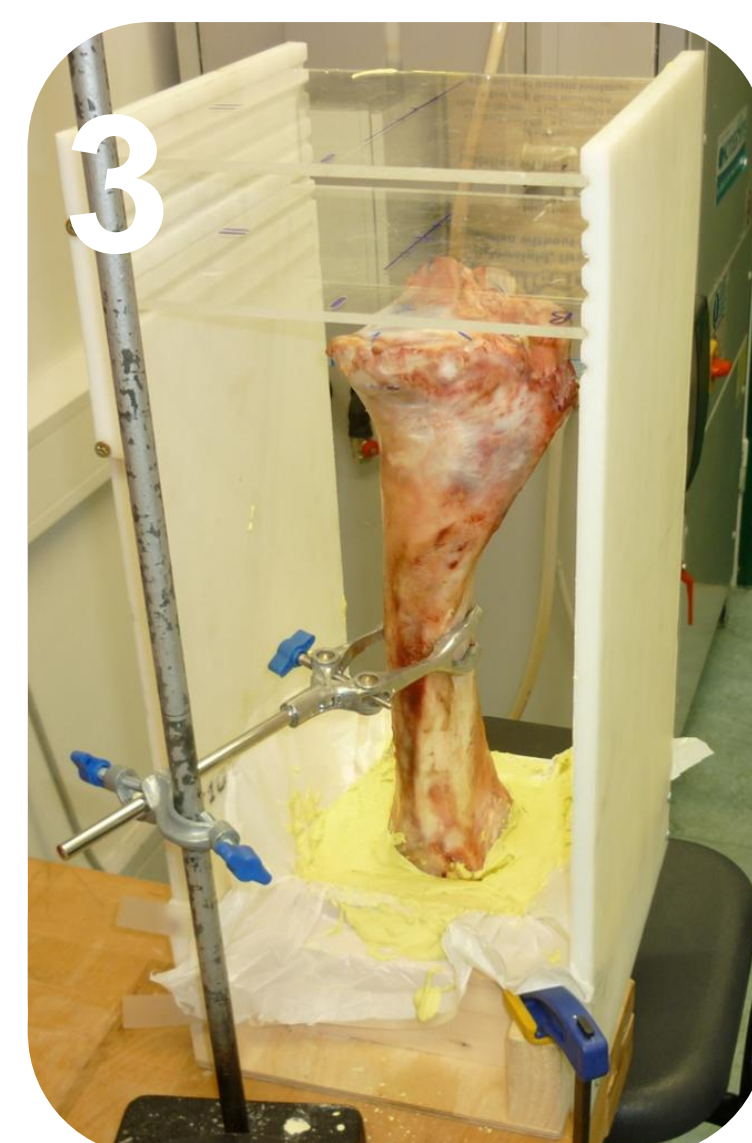
2.) The tibiae were then marked out to find the centres of the articulating surfaces in order to orientate the bones in a replicable manner for moulding.

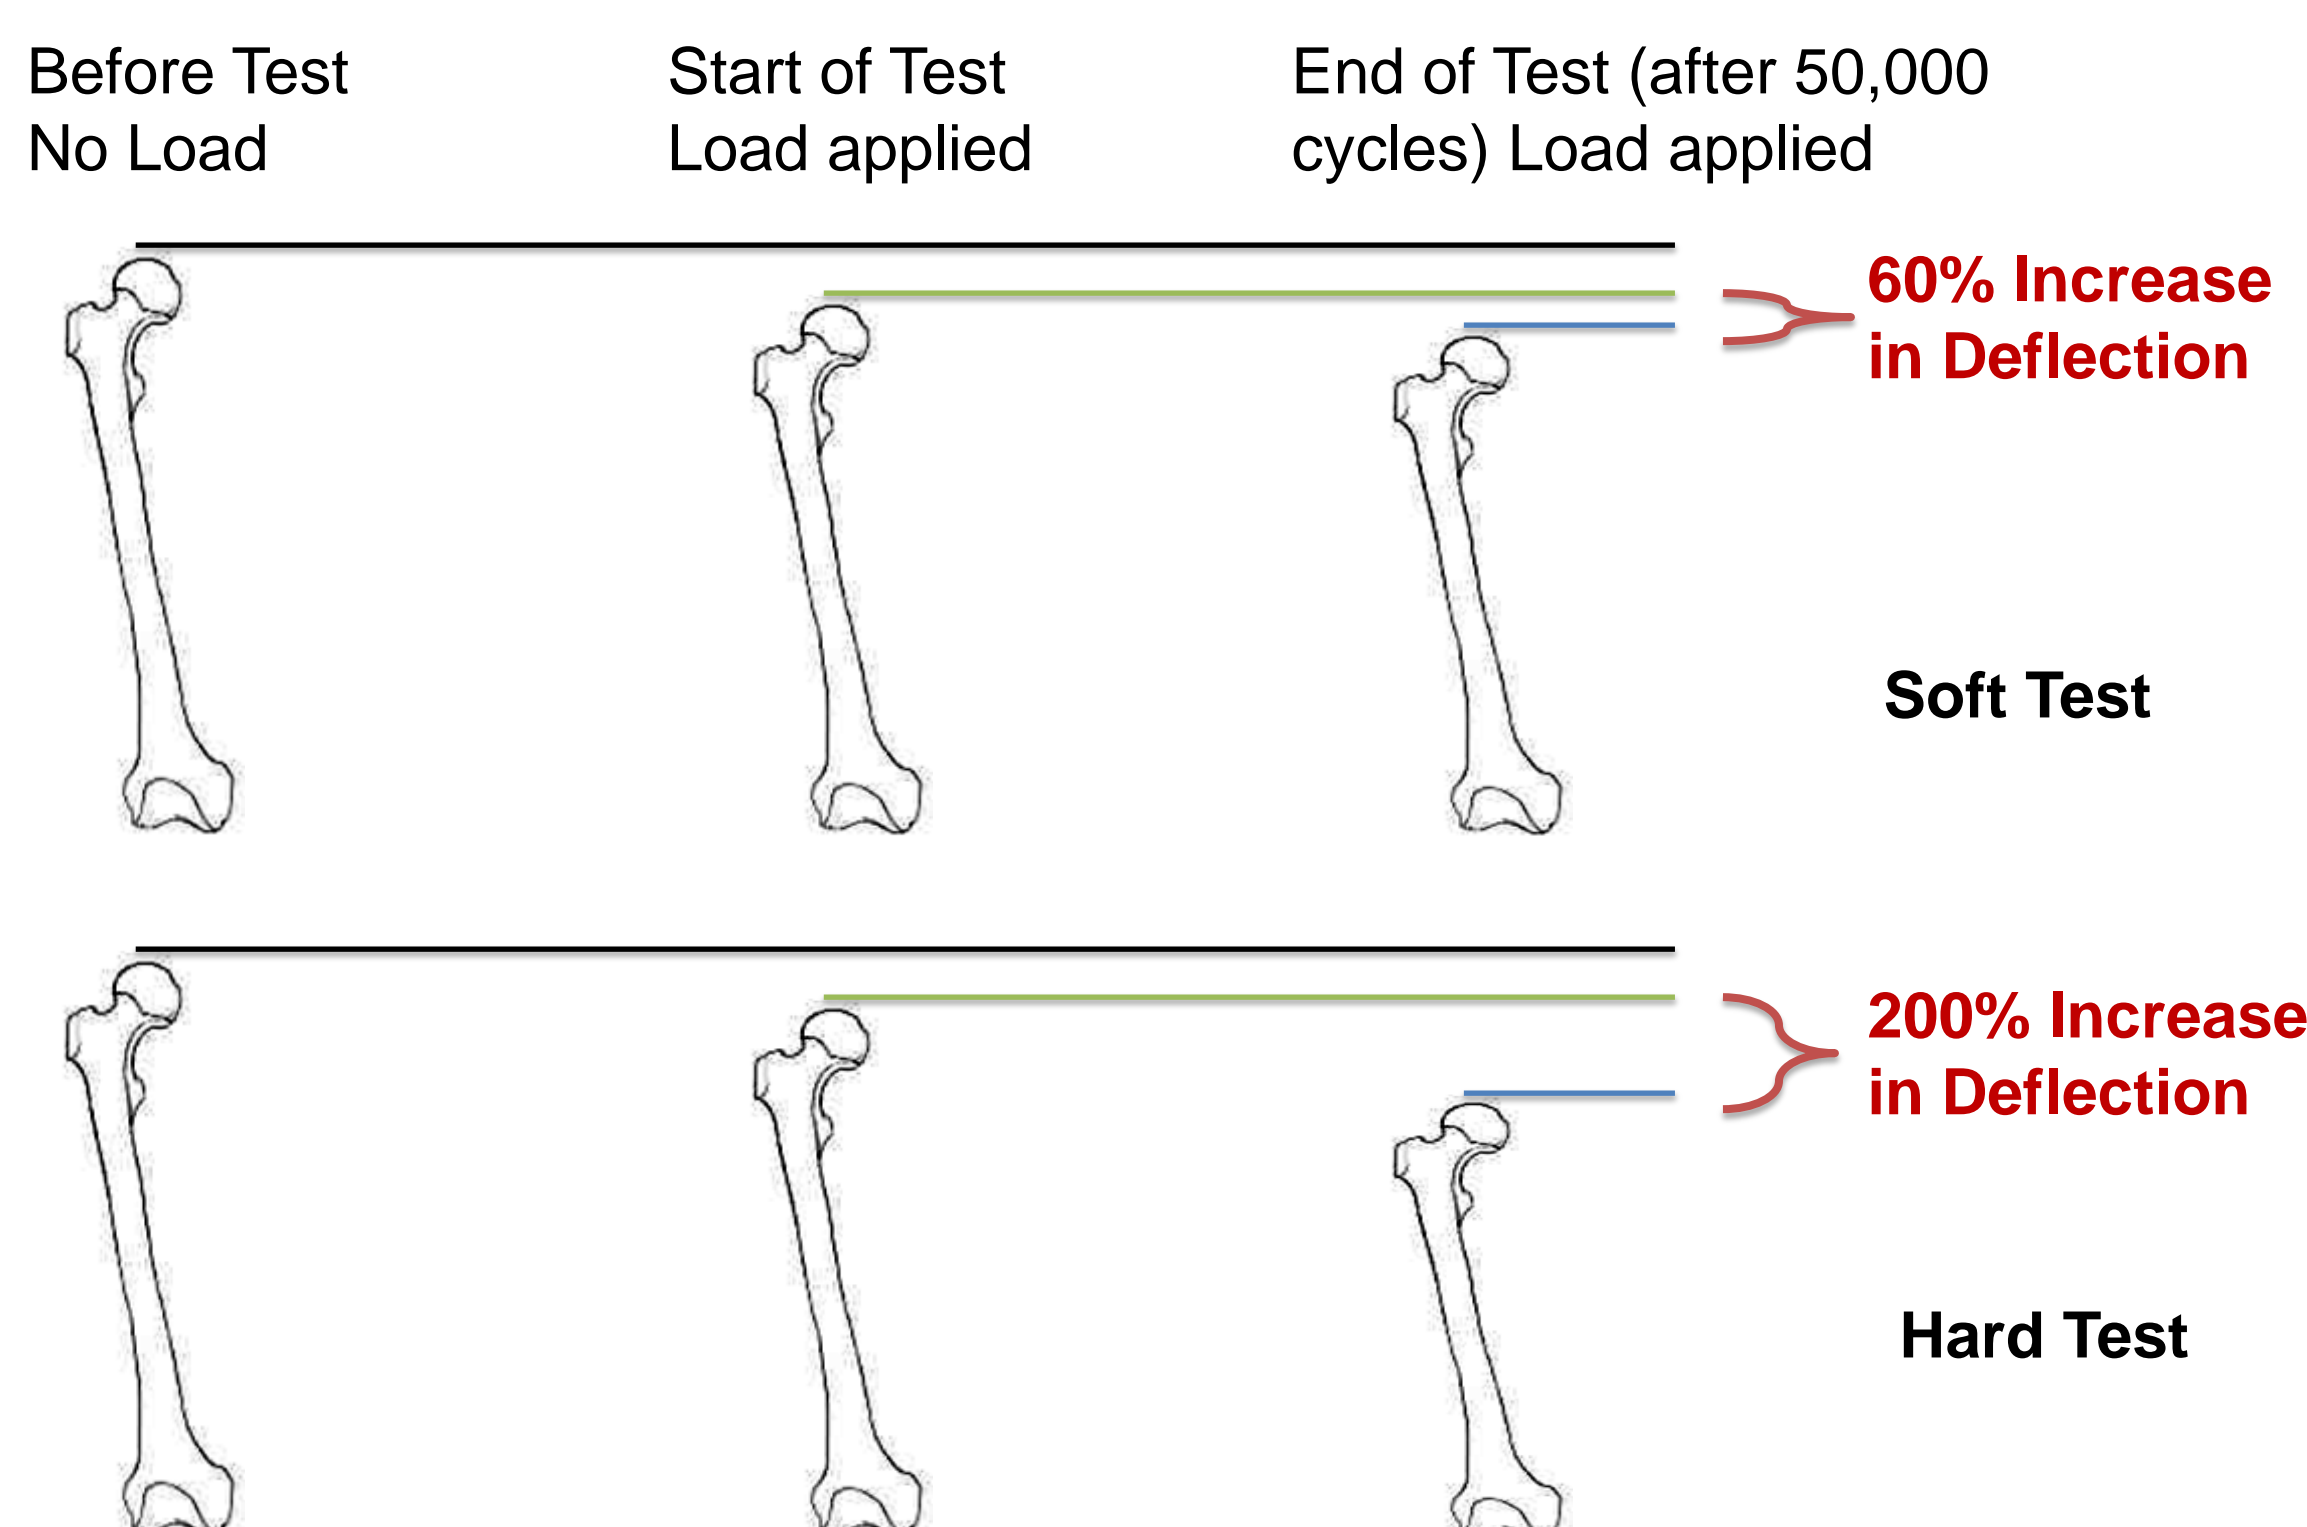
The increase in bone deflection corresponds to a reduction in the bones stiffness. This reduction in bone stiffness is as a result of damage accumulation in the bone. A large accumulation of damage in the bone corresponds to a higher increase in deflection under loading. Therefore, from the results presented, the cyclic loading on the hard surface is causing a larger amount of damage to the bone than equivalent loading on the soft surface. However there is a concern that the difference between the results may be as a result of loading differences between the two tests, differences such as:
